# SURVEY

## **EXISTING WATER ACCESS POINTS IN THE DISTRICTS OF BO, KOINADUGU AND TONKOLILI IN SIERRA LEONE**

François Bourgois\*, Pietro de Cao\*,  
Yembe Koriteh\*, Barbara Truan\*\*,  
Philippe Redon\*

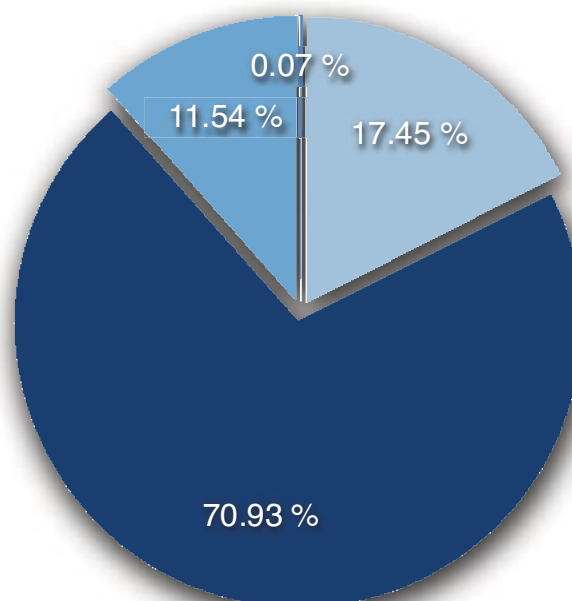
Figure 3 : System types as percentage of all identified water access point structures

Four types of structures were identified: hand dug wells (2,028 structures, 71% of the total); boreholes (499 structures, 17% of the total); open wells with rope or pulley systems (330 structures, 12% of the total); and 2 spring boxes.

- Spring box : 2
- bore hole : 499
- Hand dung well : 2028
- Open well : 330

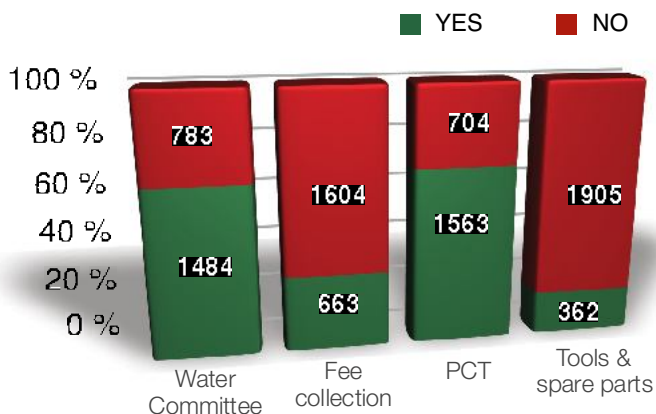
Figure 9: Presence or absence of management criteria for boreholes and hand dug wells

For all completed boreholes and hand dug wells equipped with a pump, both functioning and not functioning on the day of the survey, the presence or absence of the four management criteria were recorded. The results reveal low levels for the collection of maintenance fees and the possession of tools and spare parts throughout the three districts.

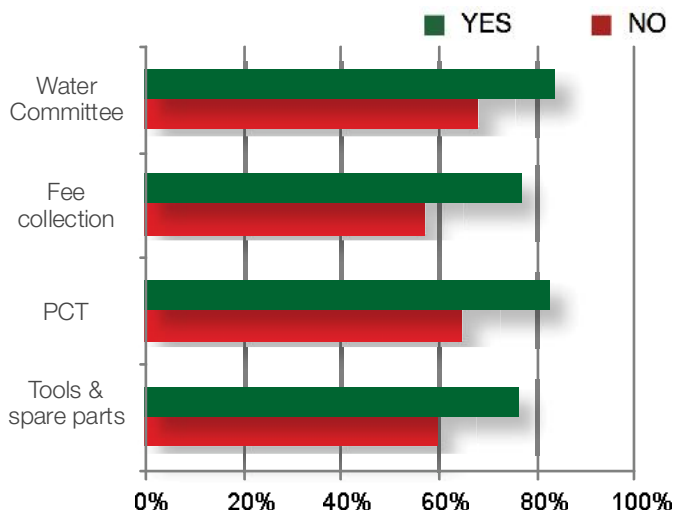
Figure 10: Proportion of functional pumps as a function of management criteria

A comparison of the proportion of functional pumps relative to the four management criteria shows a clear positive correlation between functionality and fulfilment of management criteria.

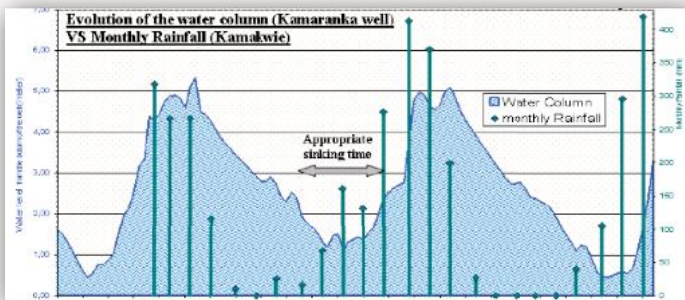
In a separate survey conducted by Inter Aide in the neighbouring district of Bombali between May 2007 and June 2009, seasonal fluctuations in the water column of nearly five metres were mapped and the window for appropriate well sinking was identified.

This relatively short period falls between the months of March and the end of June. Since timing the sinking of a well to correspond to low aquifer levels is basic knowledge and should be standard practice, and since recuperating systems that have been constructed at inappropriate times is either extremely difficult or impossible, the high rates of seasonal drying point either to a poorly managed operational timetable, dictated by supply and “pressure-to-build-quickly” mentality or to a lack of rigour in drawing up precise specification requirements for the construction contractors, a lack of supervision and proper acceptance of the works by the commissioning bodies, and a failure to impose penalties for faulty construction.
